Quality Assurance and Source Inspection

Contract #: 04-0120F4Cty: SF/ALA Rte: 80 PM: 13.2/13.9File #: 99.28**WELDING INSPECTION REPORT****Resident Engineer:**Siegenthaler, Peter**Address:** 333 Burma Road**City:** Oakland, CA 94607**Report No:** WIR-020019**Date Inspected:** 18-Jan-2011**Project Name:** SAS Superstructure**OSM Arrival Time:** 700**Prime Contractor:** American Bridge/Fluor Enterprises, a JV**OSM Departure Time:** 1900**Contractor:** Zhenhua Port Machinery Company, Ltd (ZPMC), Changxing Island **Location:** SHANGHAI CHINA**CWI Name:** Mr. Zhu Zhong Hai.**CWI Present:** Yes No**Inspected CWI report:** Yes No N/A**Rod Oven in Use:** Yes No N/A**Electrode to specification:** Yes No N/A**Weld Procedures Followed:** Yes No N/A**Qualified Welders:** Yes No N/A**Verified Joint Fit-up:** Yes No N/A**Approved Drawings:** Yes No N/A**Approved WPS:** Yes No N/A**Delayed / Cancelled:** Yes No N/A**Bridge No:** 34-0006**Component:** OBG TRIAL ASSEMBLY**Summary of Items Observed:**

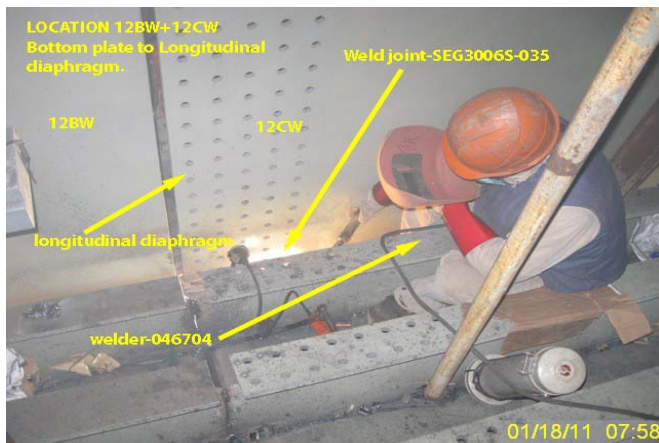
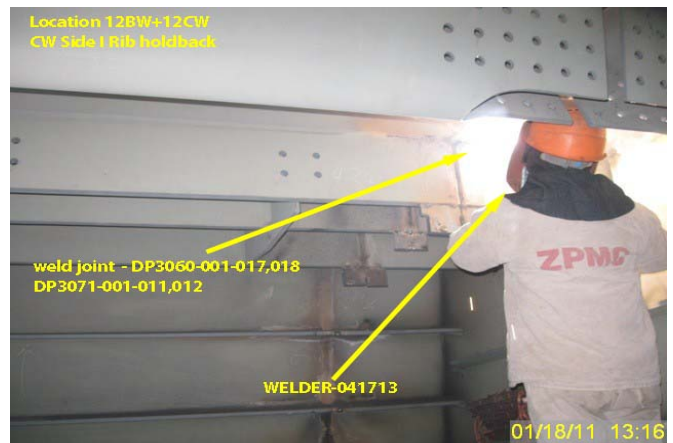
Unless otherwise noted, all work observed on this date appeared to be in general compliance with the applicable contract documents.
